WATER INFILTRATION

BURR RIDGE, IL

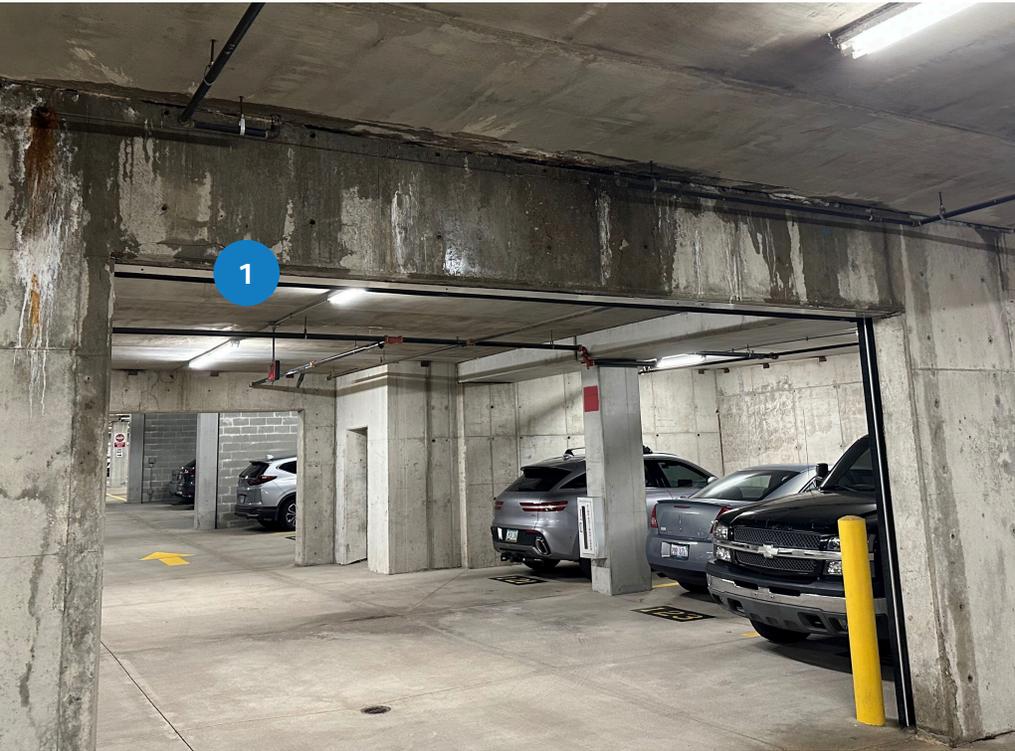
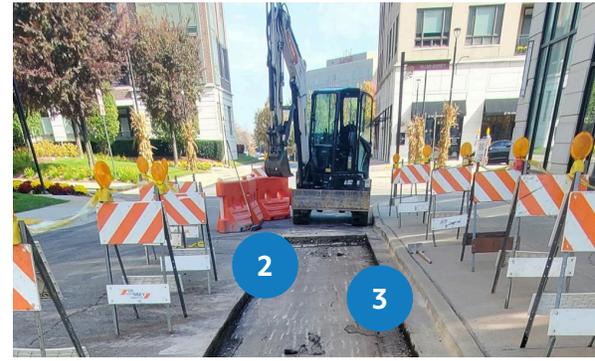
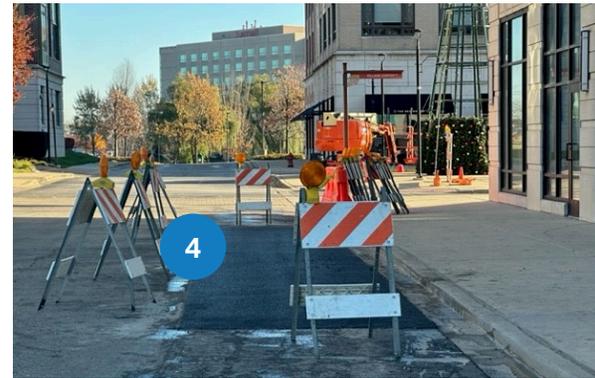
Our team was tasked with addressing persistent leaks in an underground parking garage, which were exacerbated by freeze-thaw cycles and concrete deterioration. Following an engineering review, Clarion’s Service Division uncovered significant waterproofing deficiencies including missed steel deterioration and a membrane that had not adhered to the concrete substrate—a key cause of water infiltration. Additionally, we identified structural deficiencies, including a crack running east to west, parallel to a concrete beam showing signs of rust and spalling.

Structural repairs are costly and tedious. Working with the owner, Clarion made the case for investing in long-term structural solutions that will last. Clarion’s repair plan involved cleaning the asphalt cut edges, applying a new membrane to the concrete, and patching the asphalt, fully sealing the area to prevent future leaks. Additional repairs were provided to address uncovered issues within the scope of the original bid, demonstrating our commitment to quality and client trust.
