LAB FLOOR REPAIR

AURORA, IL

PROJECT HIGHLIGHTS:

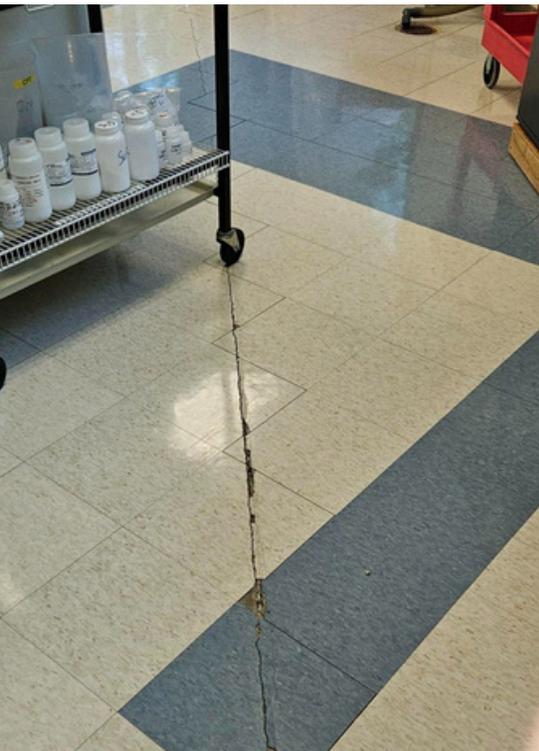
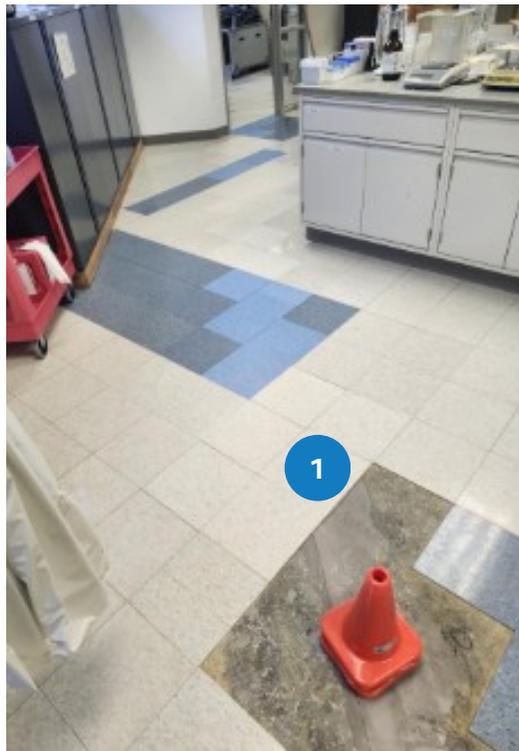
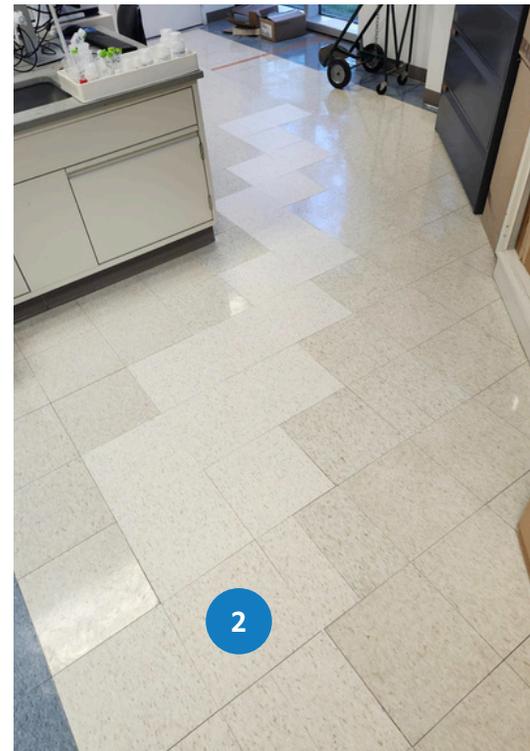
Precision, cleanliness, and experience is required to execute highly sensitive lab spaces. A repeat client required repairs to address debris buildup from an expansion joint shift that threatened the flooring and workspace environment.

To protect sensitive equipment and maintain clean workspaces, our Service Division enclosed the impacted area to contain dust and debris during construction. Our team carefully removed the damaged vinyl composition tile (VCT), chipped out old concrete for proper adhesion, and poured fresh concrete. Once the foundation was set, new VCT was seamlessly installed in the affected areas, allowing the client to avoid a full floor replacement.
